Fixing Late Model Ford Focus Engine Vibration Problems

Ford has issued a Tech Service Bulletin (TSB 11-3-24) regarding problems with engine vibration on the 2000-2011 Ford Focus. This article supersedes TSB 10-5-11 and applies to Anchor engine mount numbers 2938, 3003 and 3085.

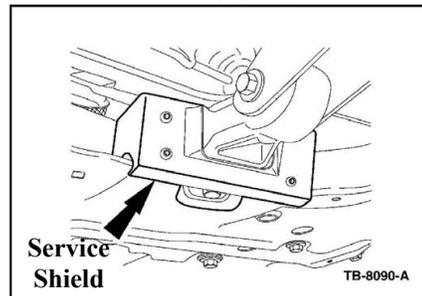
Anchor # 2938, 3003 & 3085

Some 2000-2011 Focus vehicles may exhibit an excessive engine vibration which is most noticeable when the transmission is engaged in reverse. This condition may be caused by small stones, road debris, ice or snow packed/lodged in the rear engine roll restrictor.

Inspect the rear engine roll restrictor for debris and install service shield.

1. Inspect the rear engine roll restrictor for debris.
2. Remove any debris from rear engine roll restrictor.
3. Remove the cross member-to-roll restrictor attachment bolt.
4. Install service shield.

5. Install roll restrictor attachment bolt and torque to specification.
 - a. 2000-2007 model year vehicles - 47 N.m (35 lb-ft)
 - b. 2008-2011 model year vehicles - 70 N.m (52 lb-ft)
